Final Research Report

ANALYSIS AND DESIGN OF WIRE MESH/CABLE NET SLOPE PROTECTION

1. REPORT NO. WA-RD 612.1		2. GOVERNMENT ACCESSION NO.		3. RECIPIENT'S CATALOG NO.	
4. TITLE AND SUBTITLE ANALYSIS AND DESIGN OF WIRE MESH/CABLE NET SLOPE PROTECTION				5. REPORT DATE April 2005

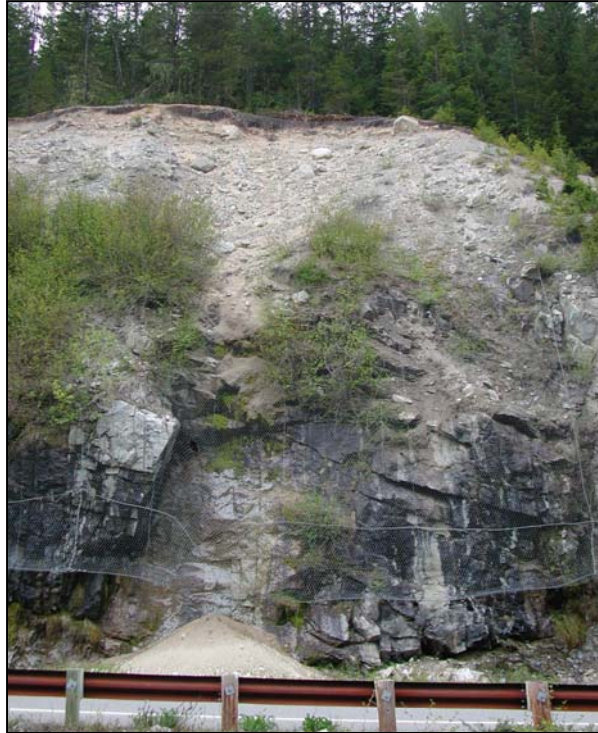
Figure 4-13. The slope conditions; snow accumulation occurs on the upper portion of the slope.

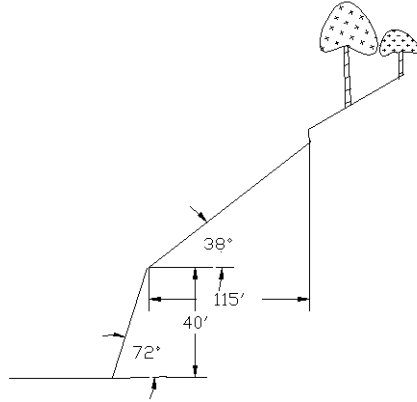
Figure 4-14. Cross-section shows upper and lower slope segments. The upper segment comprises the zone of snow accumulation on the installation.

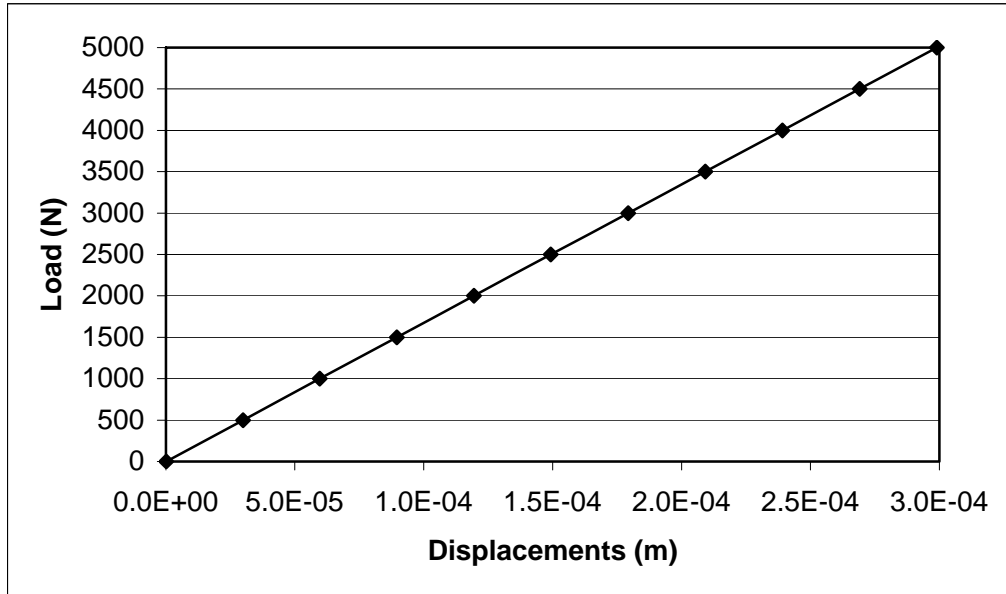
Figure 5-5. Applied load versus displacement of a cell assuming fixed sides.

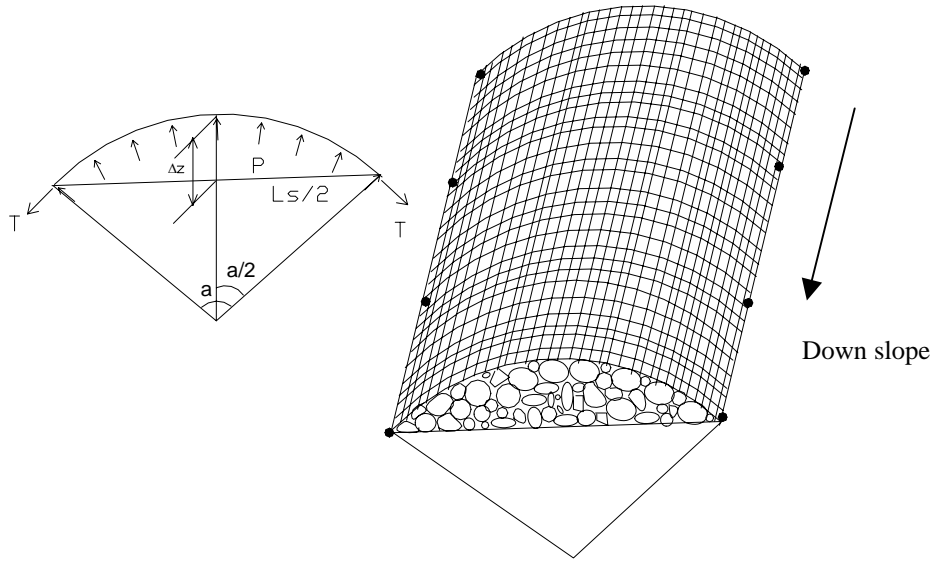
Figure 5-7. Assumed circular cross-sectional shape of the mesh and the conditions that would result in seam failure.

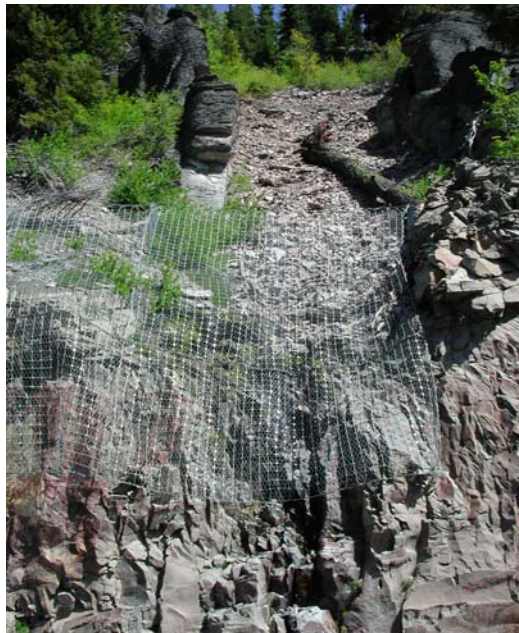
Figure 5-8. Modified cable net installation, upslope source of rockfall, and typical range of block sizes that impact the installation in a sub-perpendicular orientation.

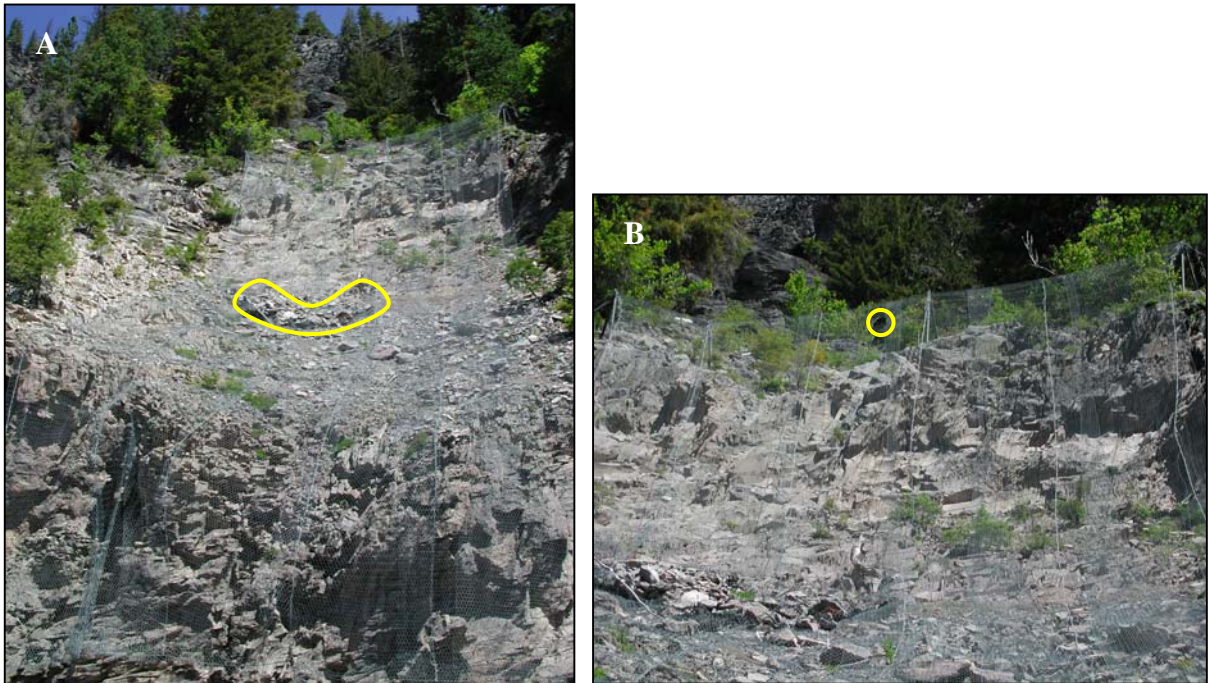
Figure 5-9. (A) Configuration of slope and installation. Yellow line outlines area of debris accumulation and rupture failure. (B) Enlarged view of top of mesh, downslope of chute. Yellow circle highlights 18-inch (450-mm) puncture of the mesh.

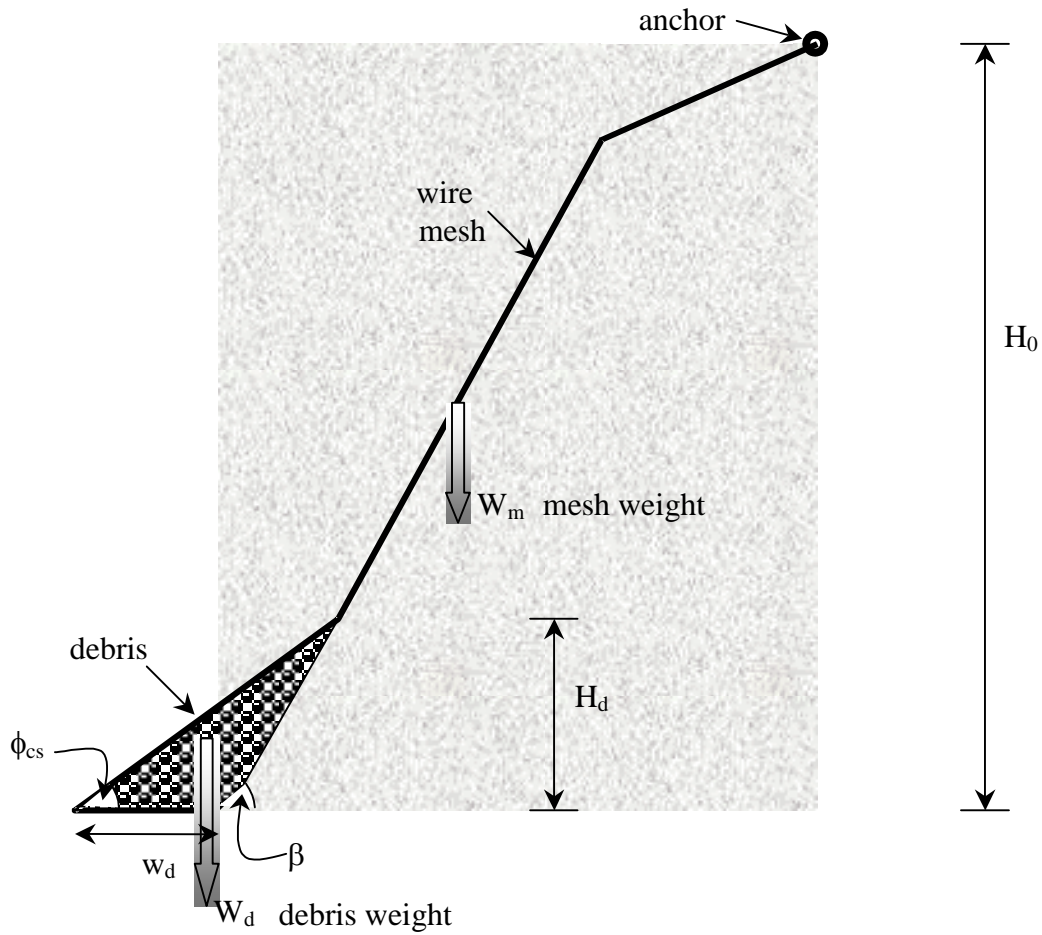
Figure 6-1. Mesh installation and loads that act on the system.

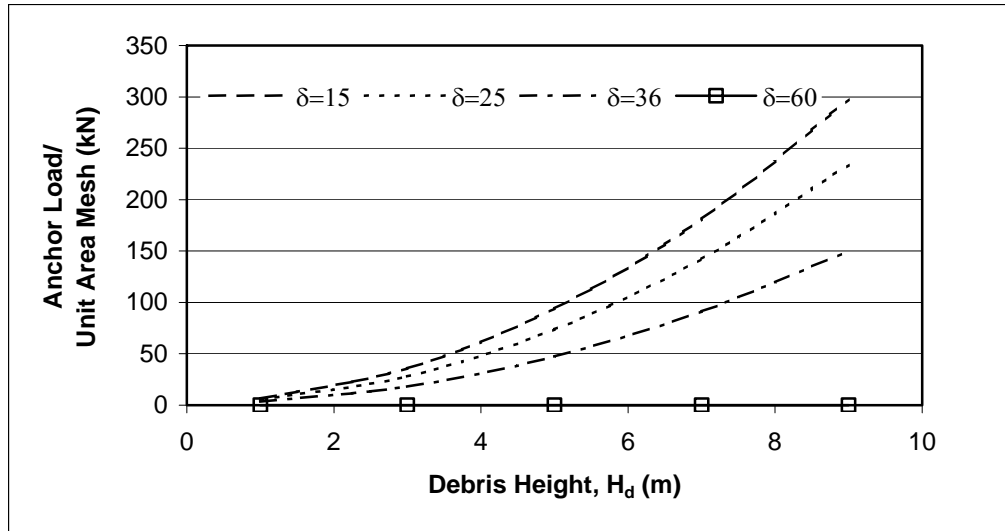
Figure 6-3. The effects of interface friction angle (δ) on anchor load for 30-m (100-ft) slope heights for a range of debris heights on a 50° slope.

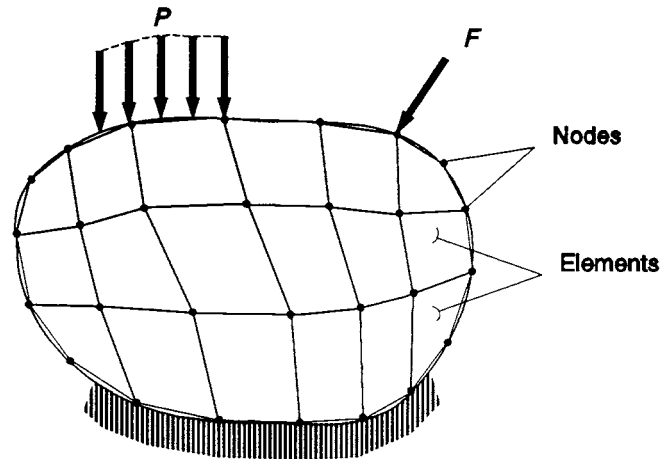
Figure 6-5. Finite element discretization shows loads (P) and forces (F) acting on mesh (Knight, 1997).

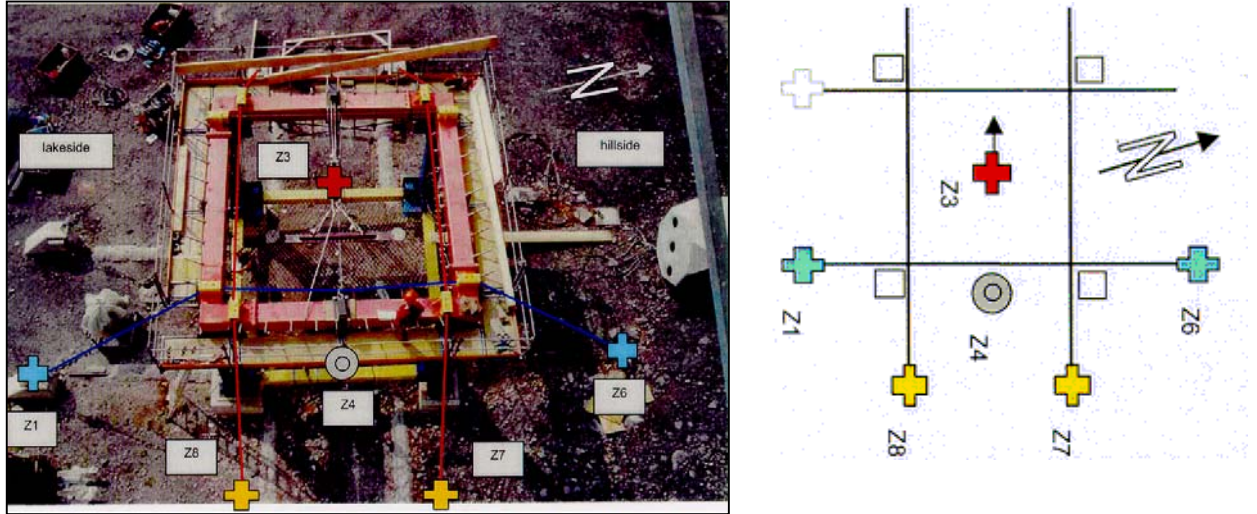
Figure 6-6. Test setup and locations of load cells. Z4 is the load cell used to measure the force at the stabilizing anchor. Z3 is the load cell used to measure the applied load. Load cells Z1, Z6, Z7, and Z8 measure force at the other supports.

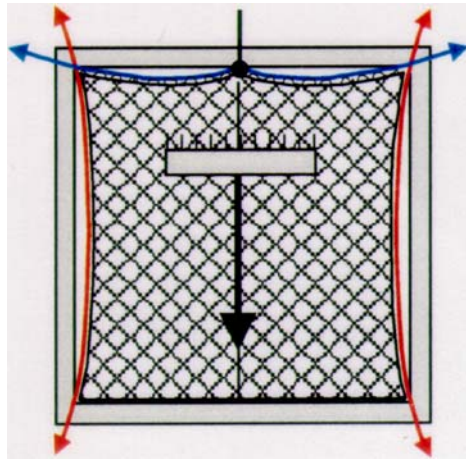
Figure 6-7. The direction of loading of the TECCO® mesh by the steel beam and the load transfer to perimeters (support ropes and anchors) of the mesh panel. The beam is fixed to a variable number of mesh cells referred to in Table 6-1. The unit of measure for the distance of the beam to the anchor is in the number of mesh cells.

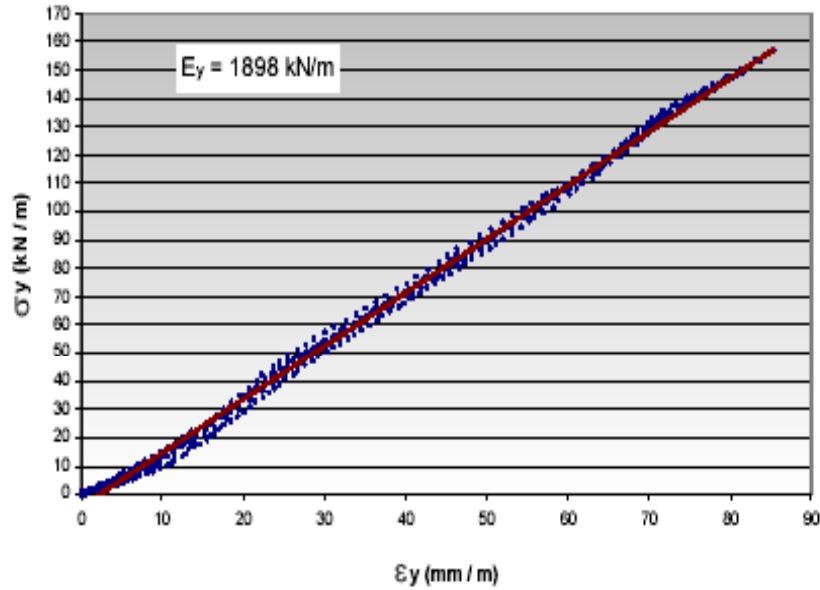
Figure 6-8. Stress- strain relationship for TECCO® G65 mesh.

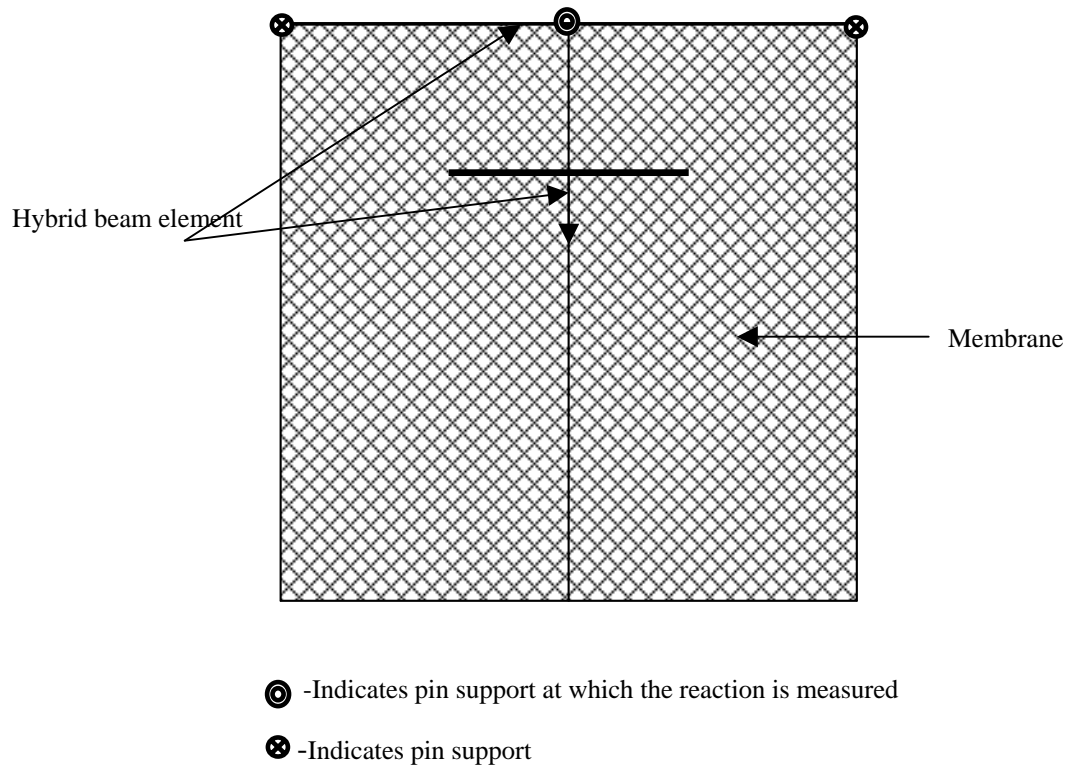
Figure 6-9. FE model setup shows locations of anchors and beam.

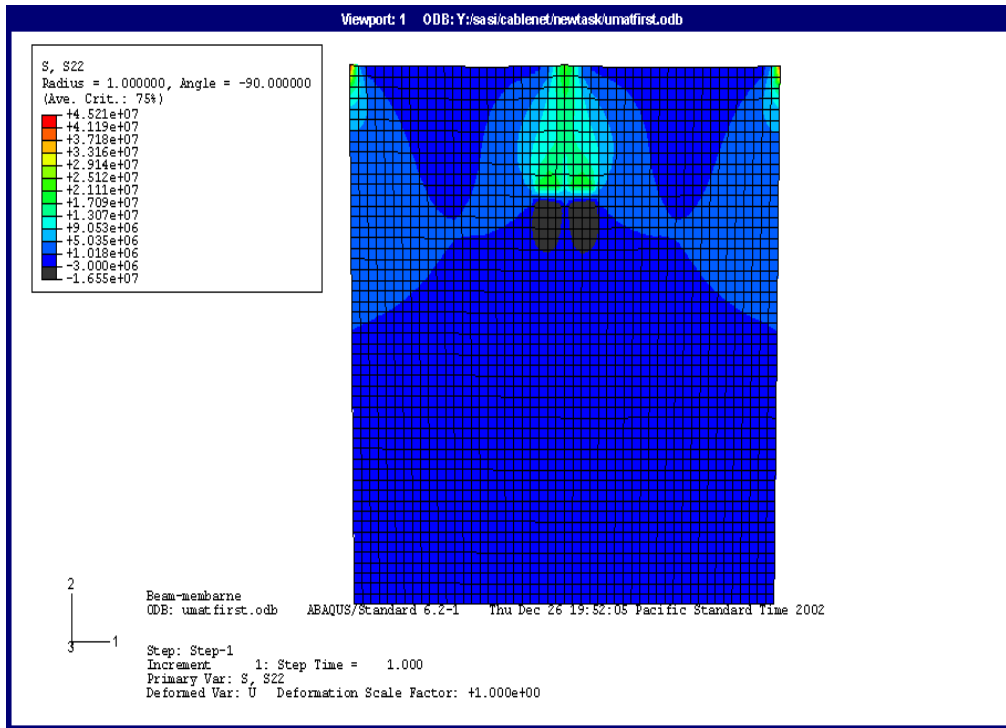
Figure 6-10. Stress contours for Test 1.

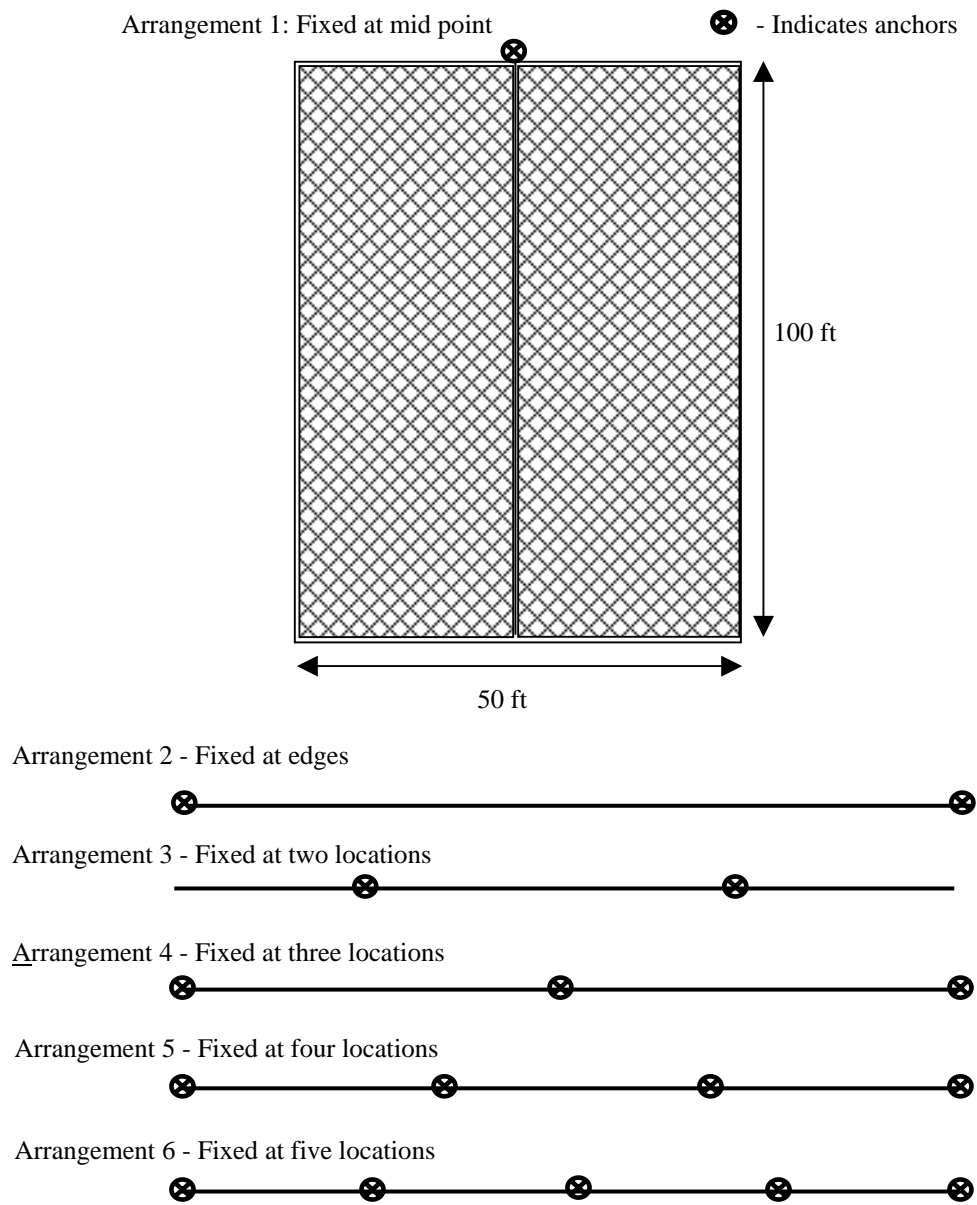
Figure 6-12. Anchor arrangements that were investigated for a mesh system of 50 ft (18 m) wide by 100 ft (30 m) long.

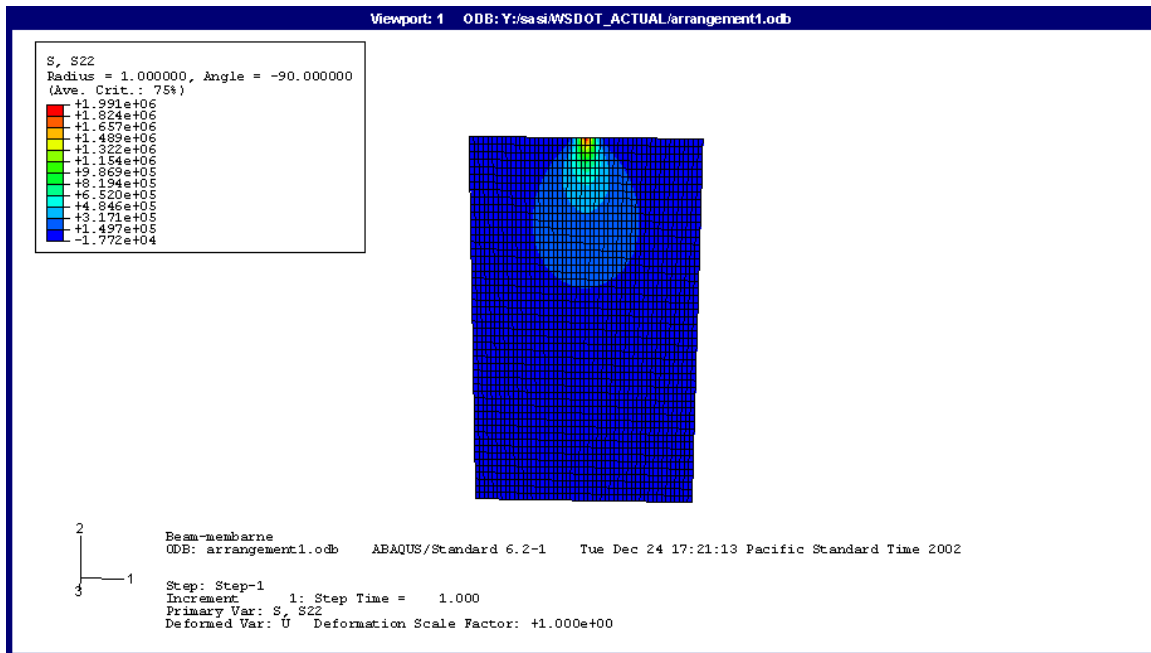
Figure 6-13. Stress contours for arrangement 1.

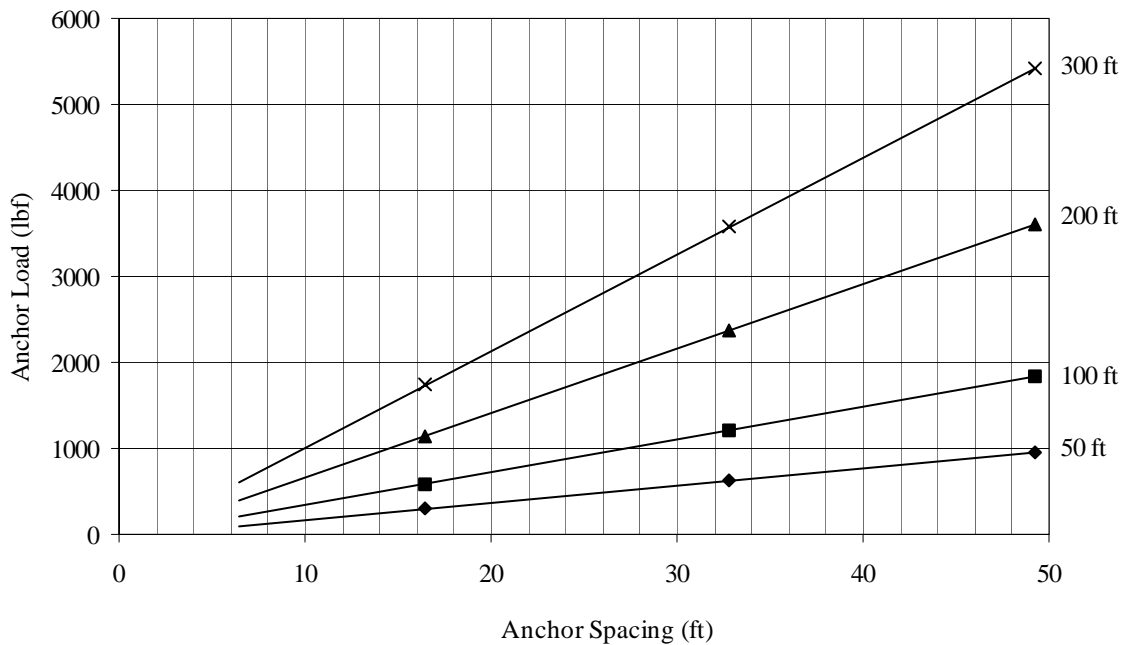
Figure 6-17. Anchor load v. spacing for double-twisted hexagonal wire mesh for a vertical slope (no interface friction) ranging in height from 50 to 300 ft (15 to 90 m).

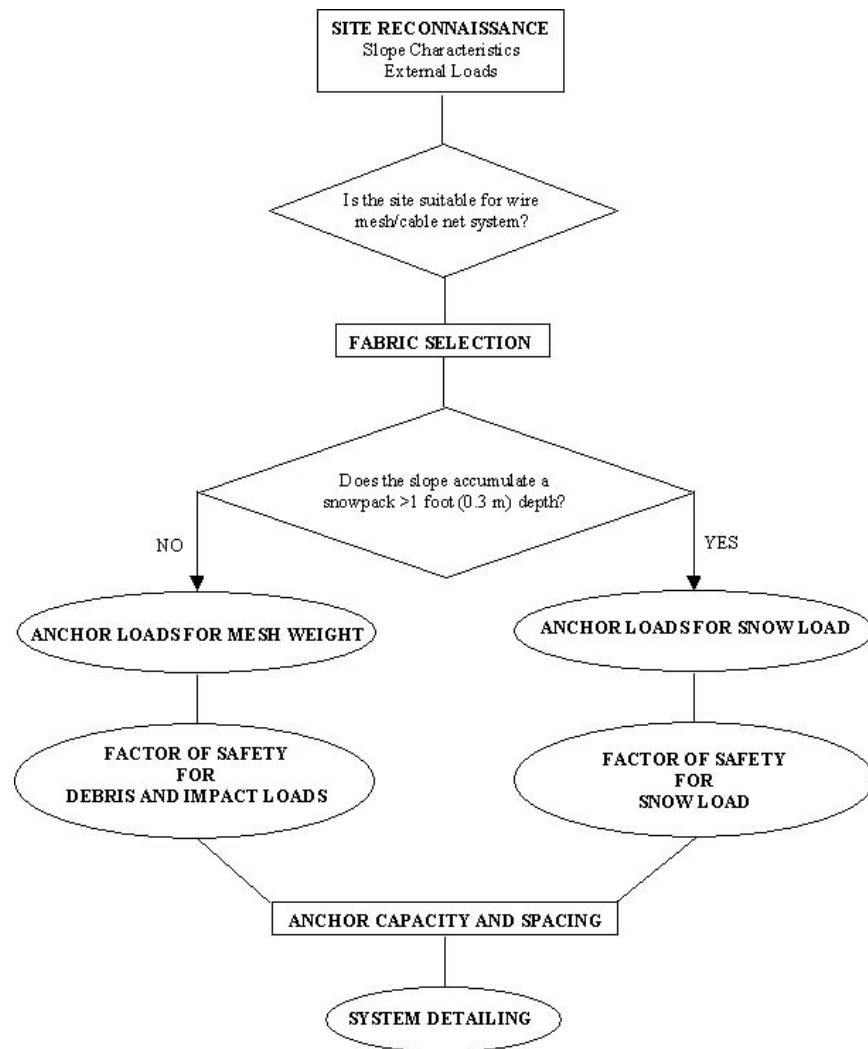
Figure 7-1. Recommended design approach for wire mesh/cable net systems.

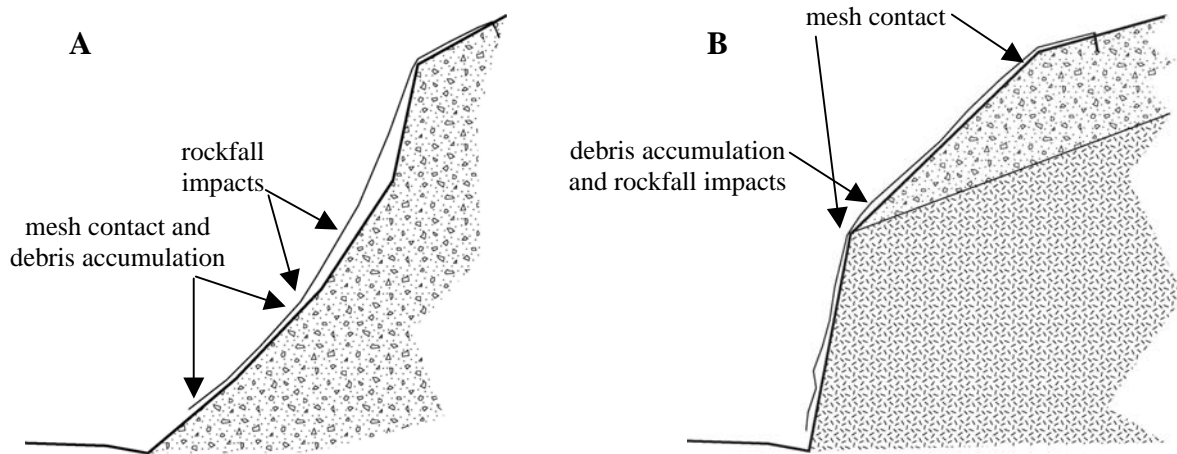
Figure 7-2. Cross-sections show typical (A) concave and (B) convex slopes and the areas of mesh contact, debris accumulation, and rockfall impacts.

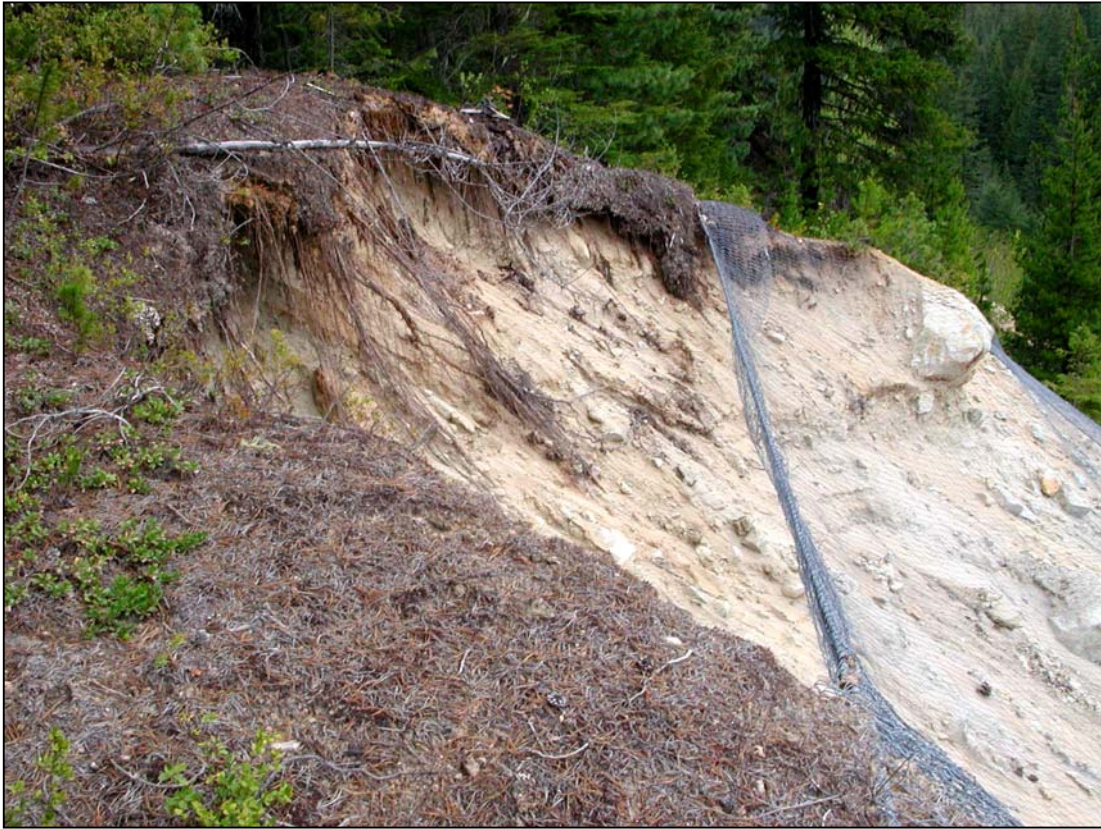
Figure 7-3. Ongoing erosion threatens a wire mesh system installed in the late 1980s in the North Cascades of Washington.

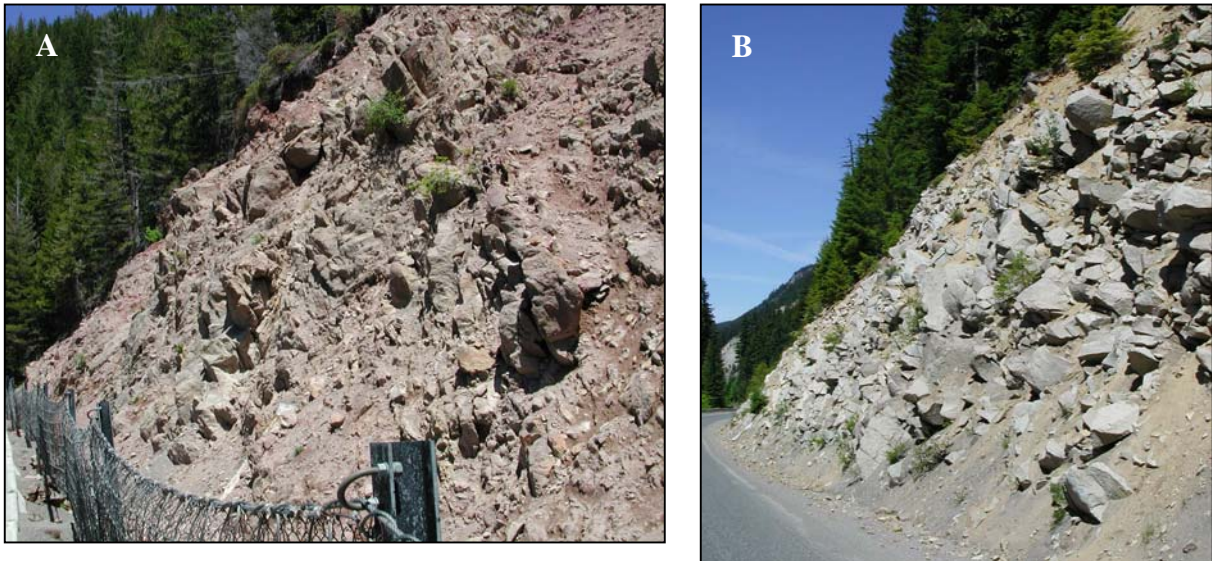
Figure 7-4. Rough slopes exhibit a high degree of surface roughness with planar, uniform profiles.

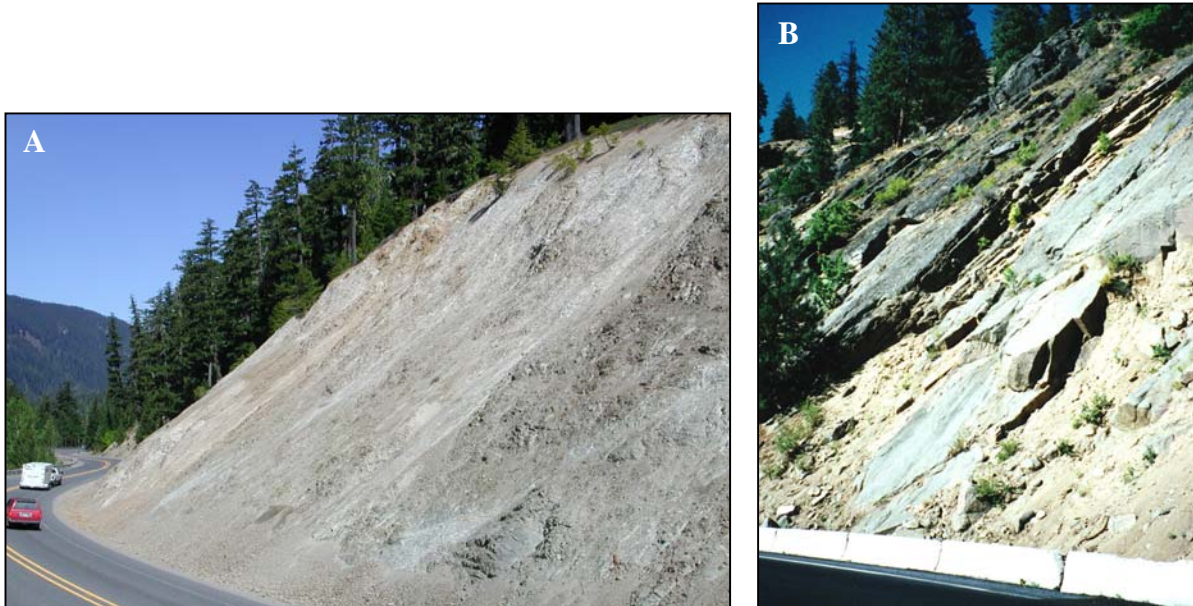
Figure 7-6. These planar slopes exhibit little surface roughness or slope irregularity. In the case of (A), the slope profile is controlled by the very highly fractured condition of the rockmass. The slope profile in (B) is the result of a highly persistent set of discontinuities that dips coincident with the slope.

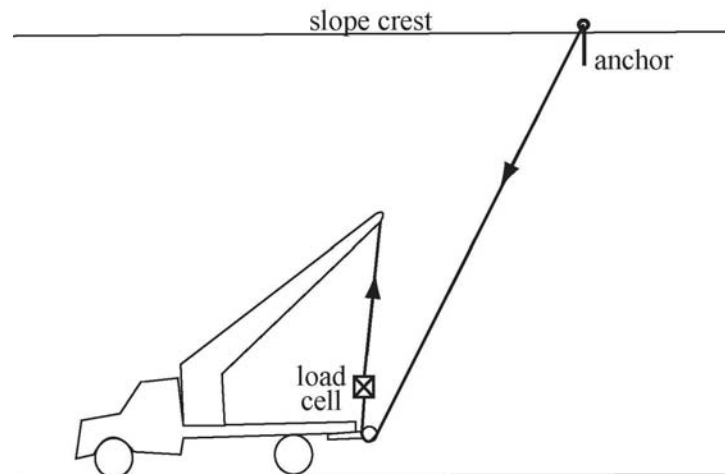
Figure 7-8. Testing setup of anchors in a sub-horizontal direction.

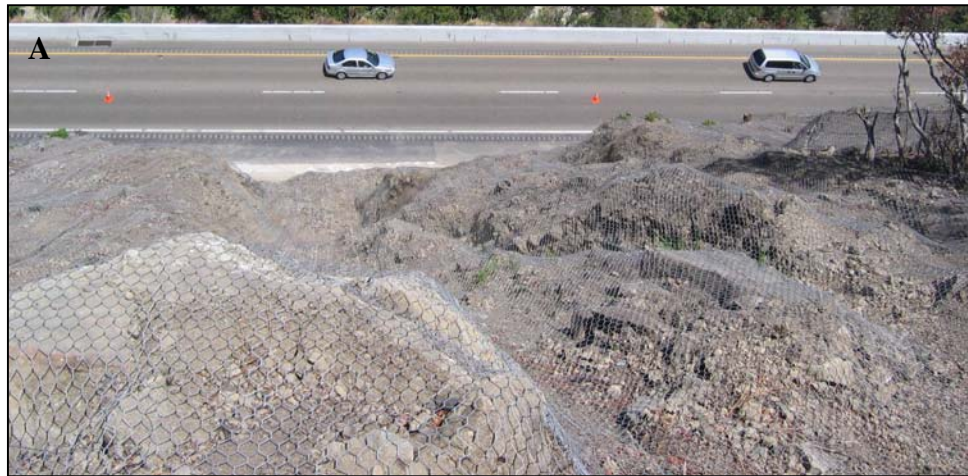
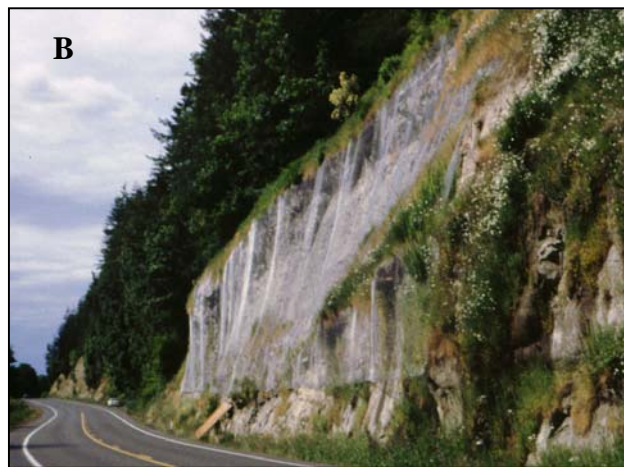
Figure 7-9. (A) The mesh was carefully installed to closely conform to this moderately inclined slope. (B) On a steep to overhanging slope where mesh conformance is generally more difficult to achieve, the mesh can become more visually apparent.

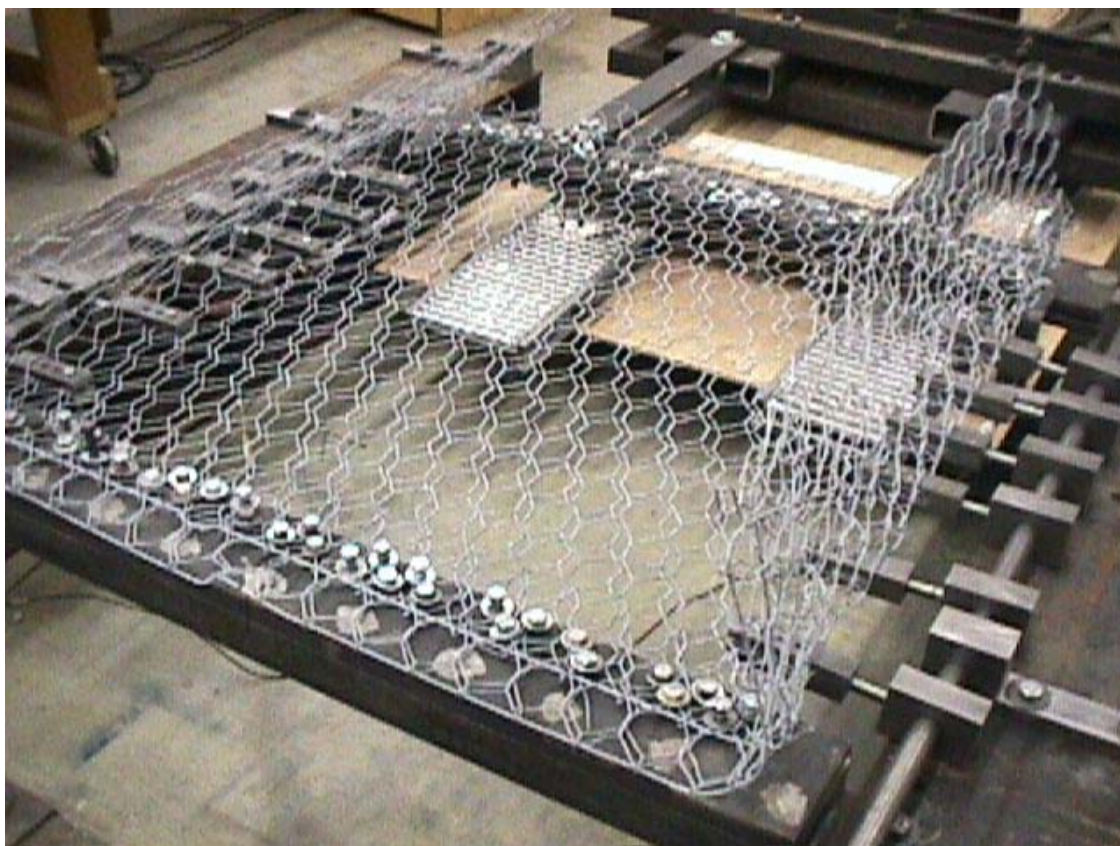
Figure 2. Testing Setup for Twisted Wire Mesh with Bolts Extended Above the Loading Plates

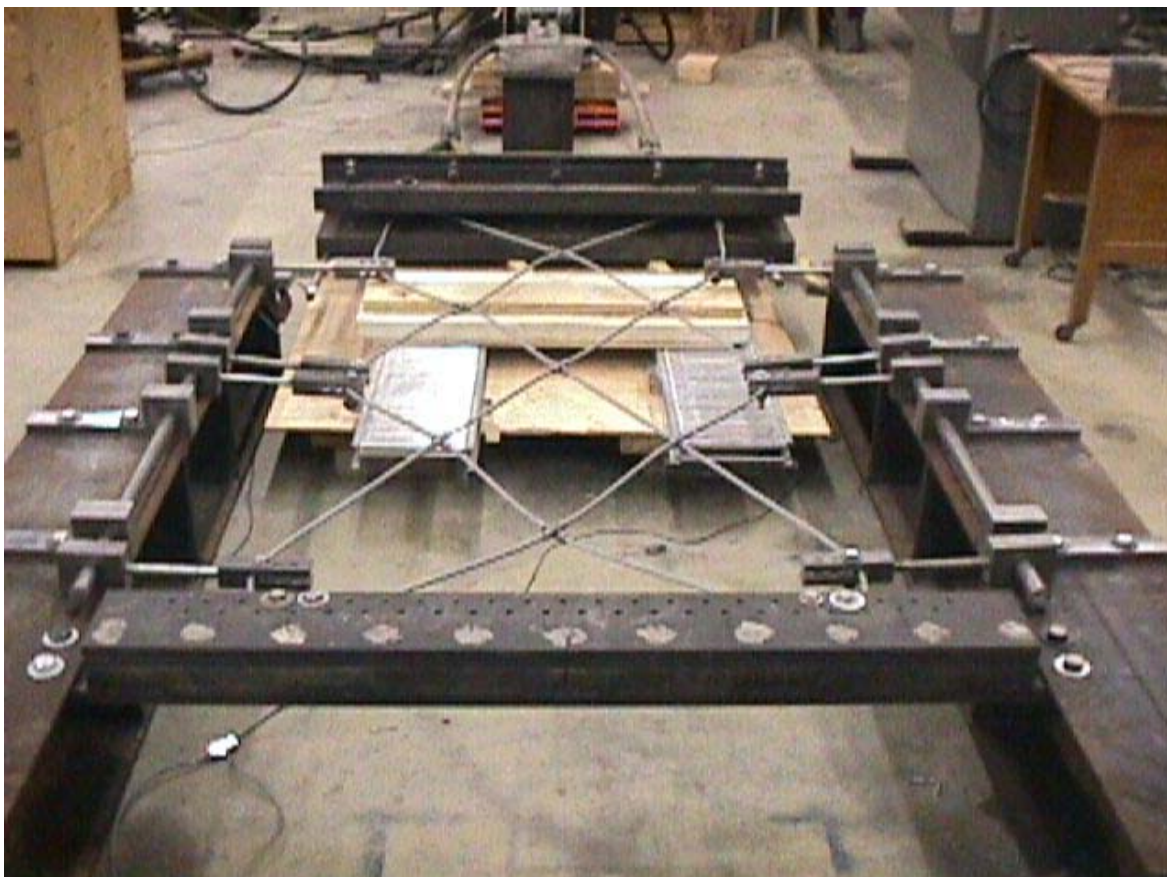
Figure 4. Testing Setup for Cable Net Mesh from Maccaferri Utilizing Modified Test Apparatus

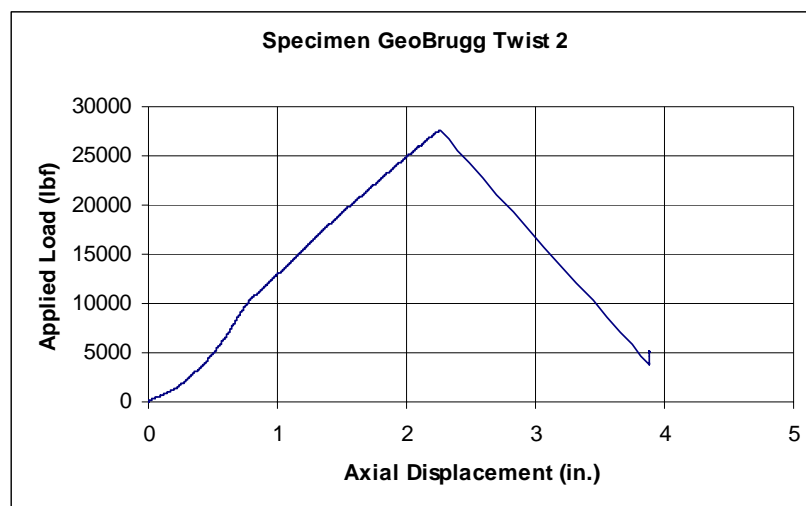
Figure 5. Testing Typical Load Versus Displacement Plot for Determining Elastic Modulus Values

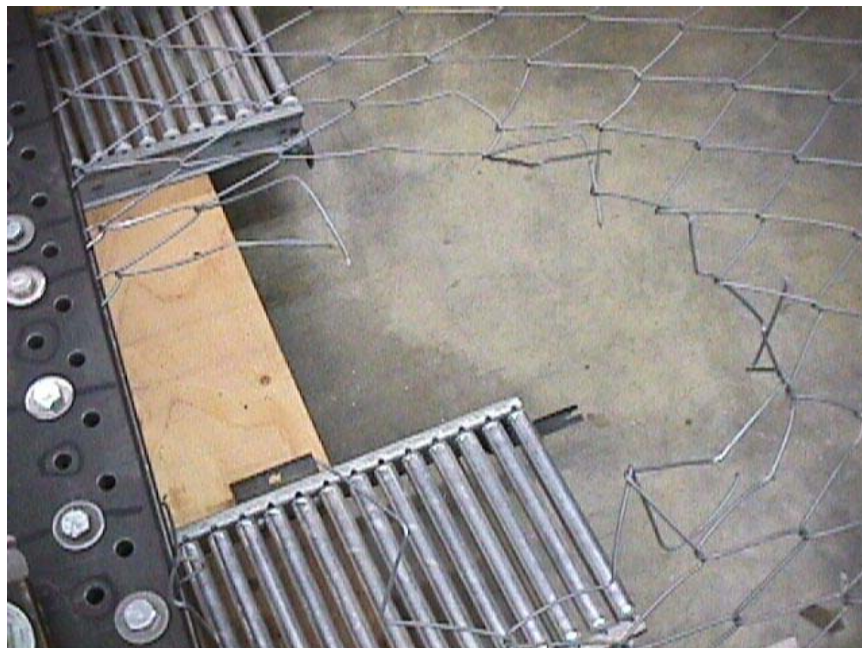
Figure 6. Typical Failure for GeoBrugg Twist Meshes

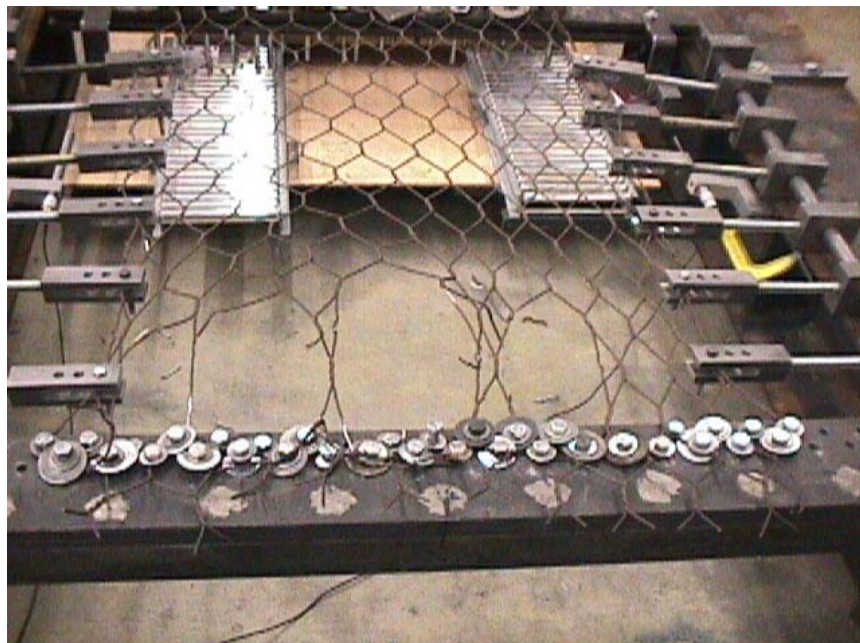
Figure 7. Typical Failure for Maccaferri Twist Meshes

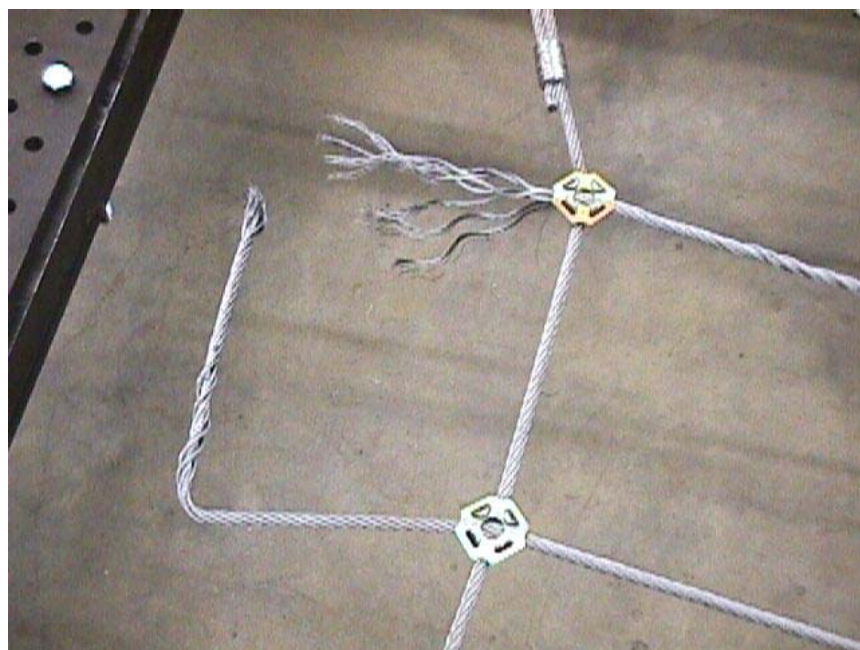
Figure 8. Cable Breaking Failure of GeoBrugg Cable Specimens

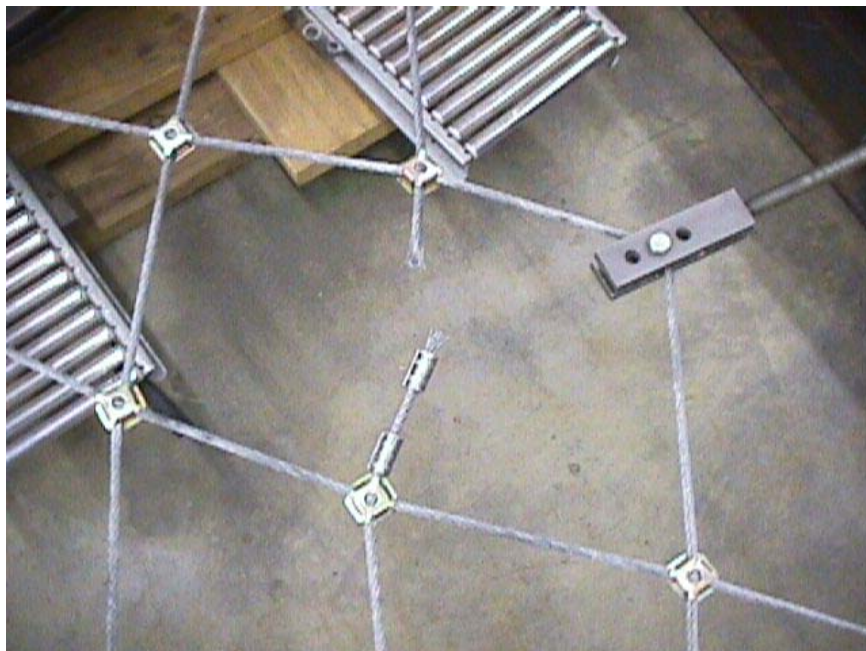
Figure 9. Cable Slippage Failure of GeoBrugg Cable Specimen

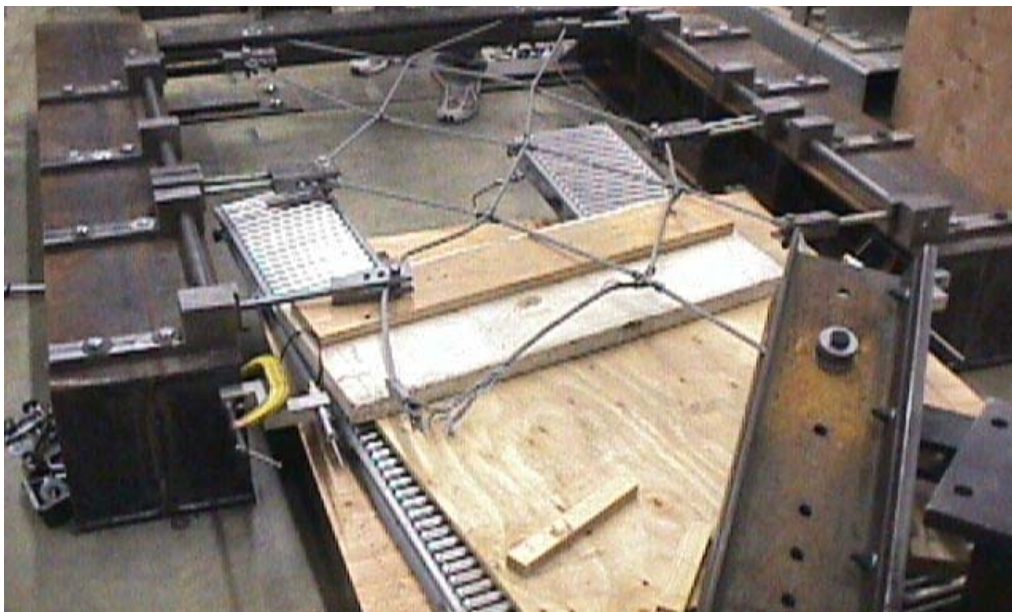
Figure 10. Typical Cable Failure of Maccaferri Cable Net Specimens
